Water Resource Pollution and Impacts on the local livelihood: A case study of Beas River in Kullu District, India

P. RANJAN MISHRA ^{*a} and R. K. NADDA^b

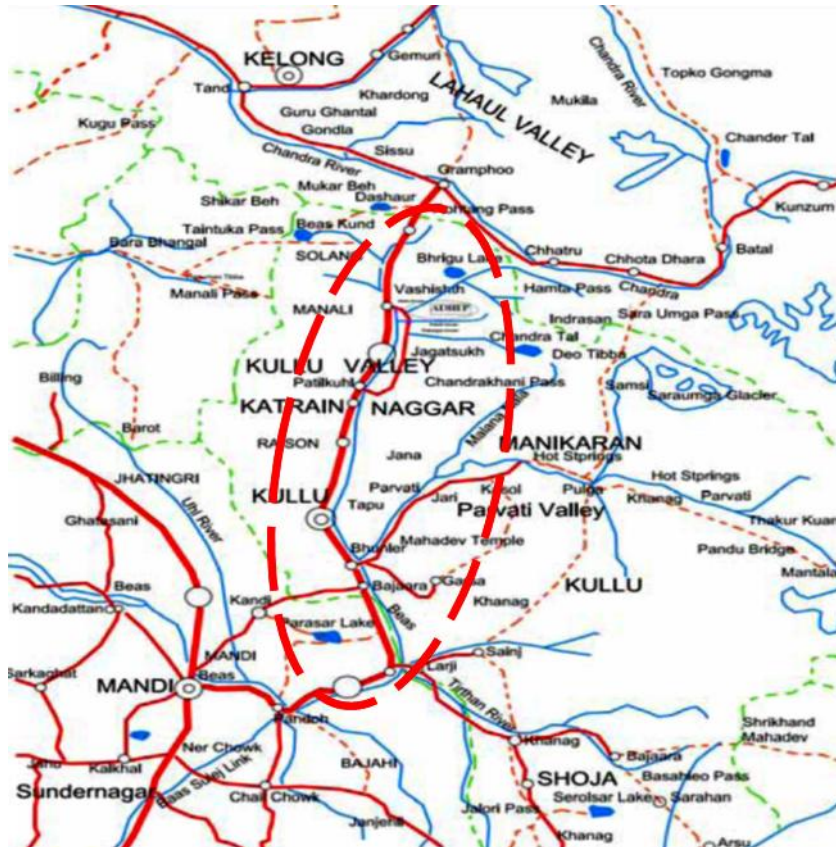
Figure 2 Map showing the exact location of the sampling points marked as tiny white circles over the red line depicting river in the valley (Source: Non-Technical Summary, Environmental and Social Impact Assessment: 192 MW Allain Duhangan Hydroelectric Power Project, Tehsil Manali, District Kullu, Himachal Pradesh, February 2009, Page-2).

The study area comprises of Beas River from Manali to Larji along NH21 between upstream Manali town and downstream of Larji dam at 15 locations. The actual points of sampling for the study have been shown above the thick broken red line that shows the Beas River in the

middle of the map (Figure 2). The study points were carefully chosen so as to get representative samples in order to interpret the impact due to sewage and solid waste dump into the river.

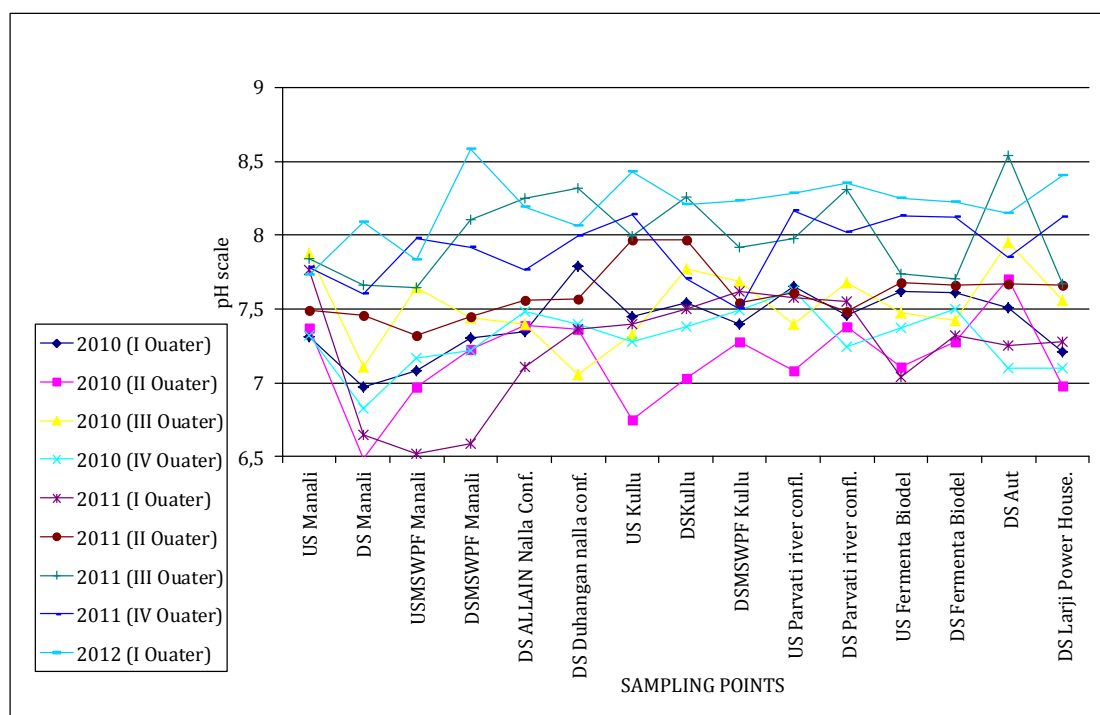
Figure 3 pH Variation during study period

The analysis of the pH graph shows that pH values remain in between 6.5 to 8.5 in all the quarters of the study period which is in an acceptable zone according to surface water quality standards. It has also come into the picture that the pH value has decreased in DS Manali as compared to US Manali on consistent basis in almost every studied quarter due to the pollution load of Manali city. Downstream of Kullu has also shown similar results, which is indicative of

the fact that the river stretch between these municipalities receives organic pollutants in the form of leachates from solid waste dumps and the untreated sewage.

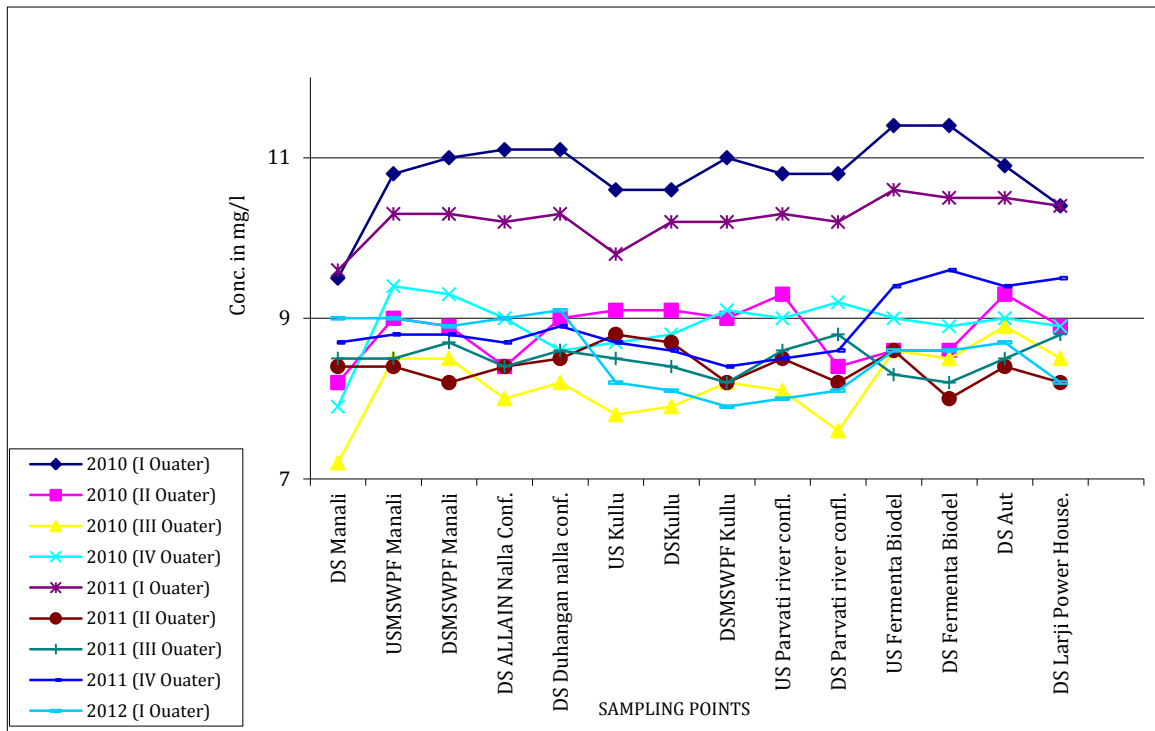
Figure 4 DO Variation during study period

After analysing the DO graph, the results show that the DO level ranges from 7 to 11 mg/l throughout the river stretch under study. The DO level in Beas River is quite high due to

its turbulent nature. The graph shows that there is drastic depletion in the DO level at DS Manali as compared to US Manali which indicates the contribution in pollution due to Manali town. It is also noticed that the DO level increases towards reaching DS Larji power house in most of the quarters as the river gets stabilised after reaching Kullu. This justifies the river self-purification process and the Biochemical Oxygen Demand (BOD) stabilization.

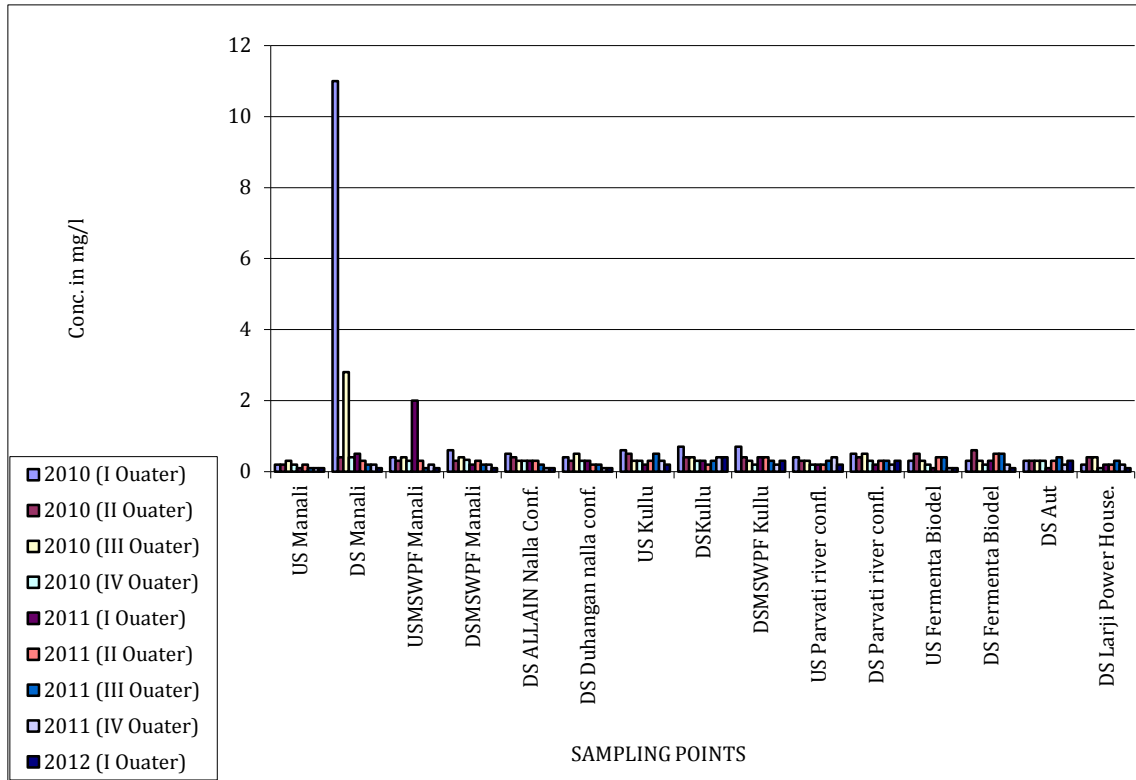
Figure 5 BOD Variation during study period (More clear illustration in appendix)

Biochemical Oxygen Demand (BOD), which is equivalent to the amount of oxygen required by aerobic micro-organisms to decompose the organic matter in a sample of water, such as that polluted by sewage. It is used as a measure of the degree of water pollution. The level of BOD has been found to be at an increased level downstream in each municipality. The BOD graph shows that the BOD

level ranges from 0.1 to 0.7 mg/l in almost all the locations of study area except in DS Manali where it reaches to 11.0 & 2.8 mg/l in first & third quarter of the year 2010 respectively. It is worth mentioning that most of the hotels are located along the river bank and they discharge their partially treated or untreated sewage directly into the river. The leachates that originate as a result of solid waste dumps from the vegetable and fruit markets, sludge from the drains,

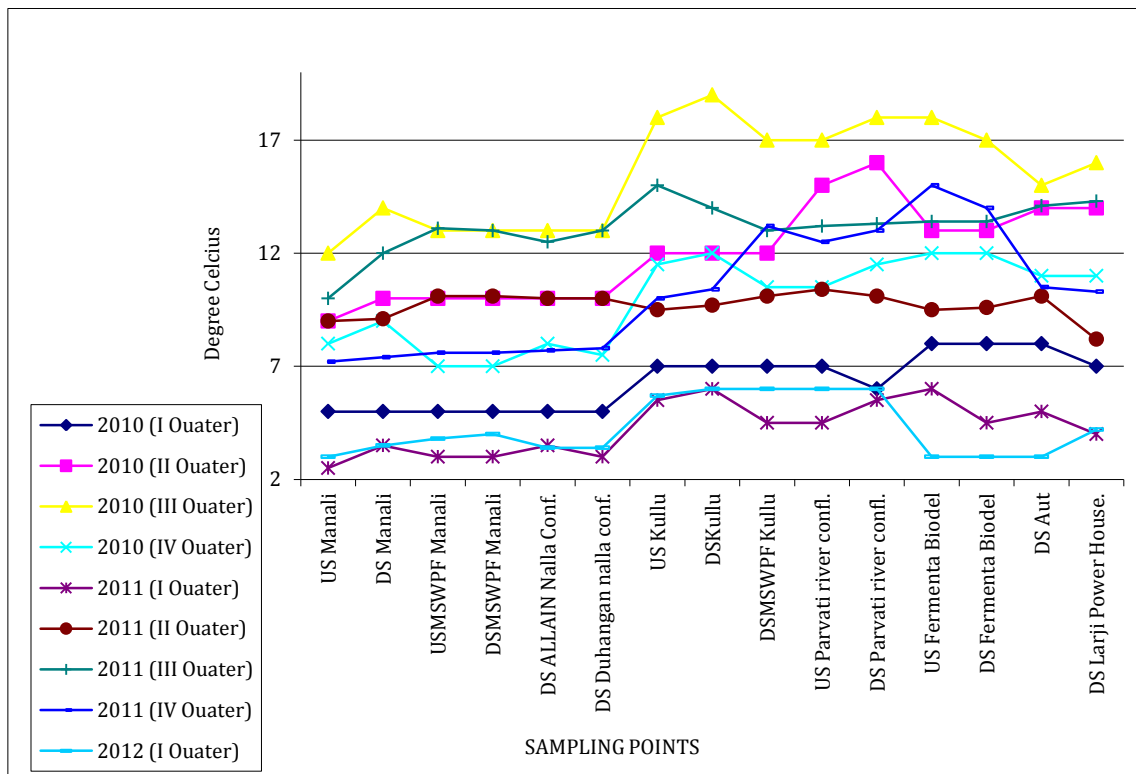
Figure 6 Temperature Variation during study period

The temperature graph shows that the temperature ranges from 2.5 to 19 degree Celsius which shows only seasonal variations. However, temperature of river water has been found to be comparatively high at all downstream points of sampling.

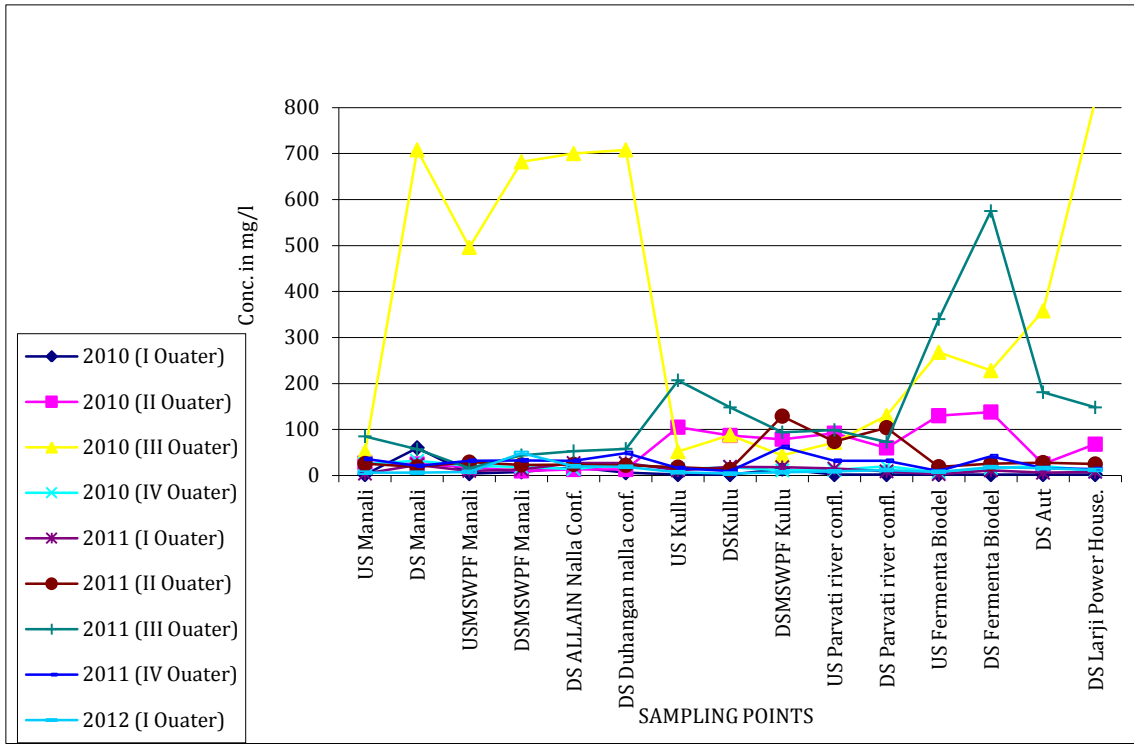
Figure 7 TSS Variation during study period (More clear illustration in appendix)

The TSS graph shows that the TSS values are high in the third quarter of

both the years which is only due to the pre-monsoon period. In the rest of the quarters the TSS values are quite stable. It has also been observed that in the year 2010 the TSS value of DS Manali is higher as compared to US Manali which is only due to the pollution load of Manali city as indicated from above parameters. TSS values are higher on account of increased construction along the river banks in one form or the other. The hydropower companies also flush their silt from time to time.

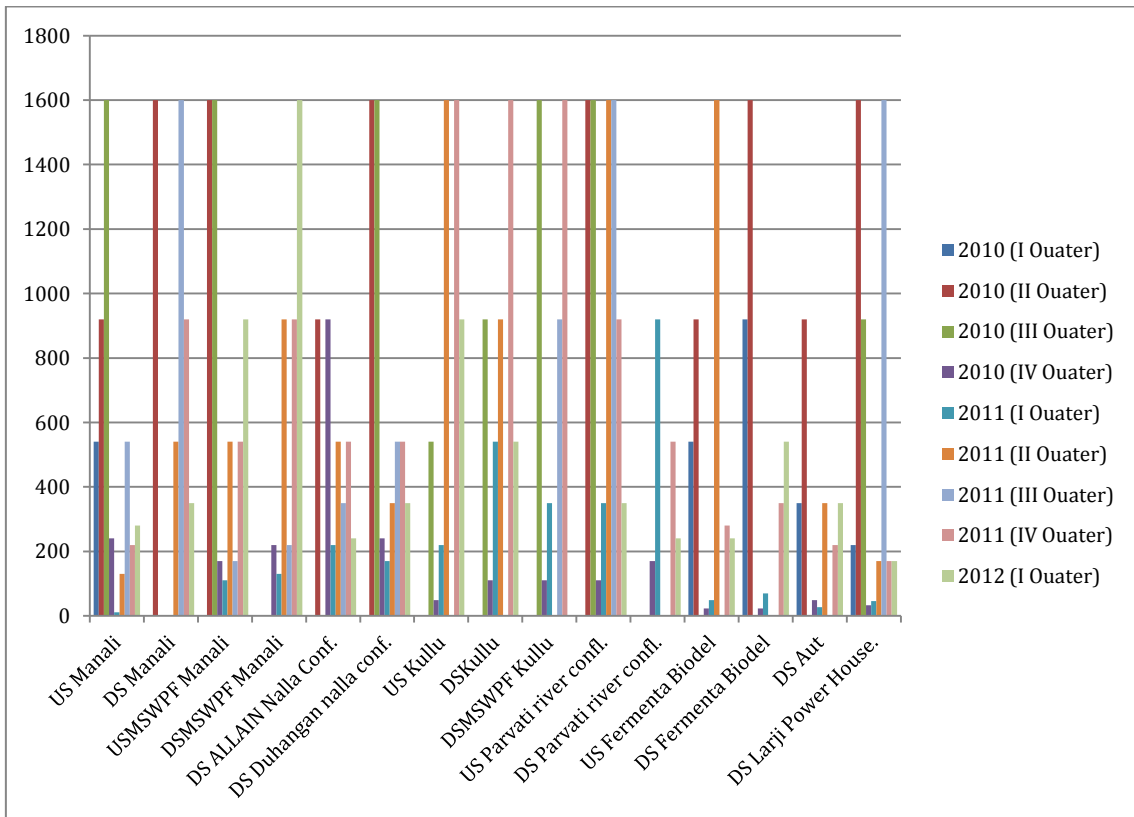
Figure 8 Total Coliforms (MPN/100ml)

During the study period, bacteriological sampling was also carried out at every point as pollution in DS cannot be ruled out due to various anthropogenic activities, and it is supported from the study that Coliform level (TC & FC) were found at increased levels at all DS points of the study area (Figure 8). The Total Coliform level (Most Probable

Number/100 ml) is more than 500 in contrast to the standard of less than 500 set by central Pollution Control Board in India for outdoor bathing or recreational activities (Figure 9). The TC level should not exceed a number of 50 for drinking water as per the same standard, but on contrary the Total Coliform level at the sampling points have been found to be more than the standard required for drinking water.

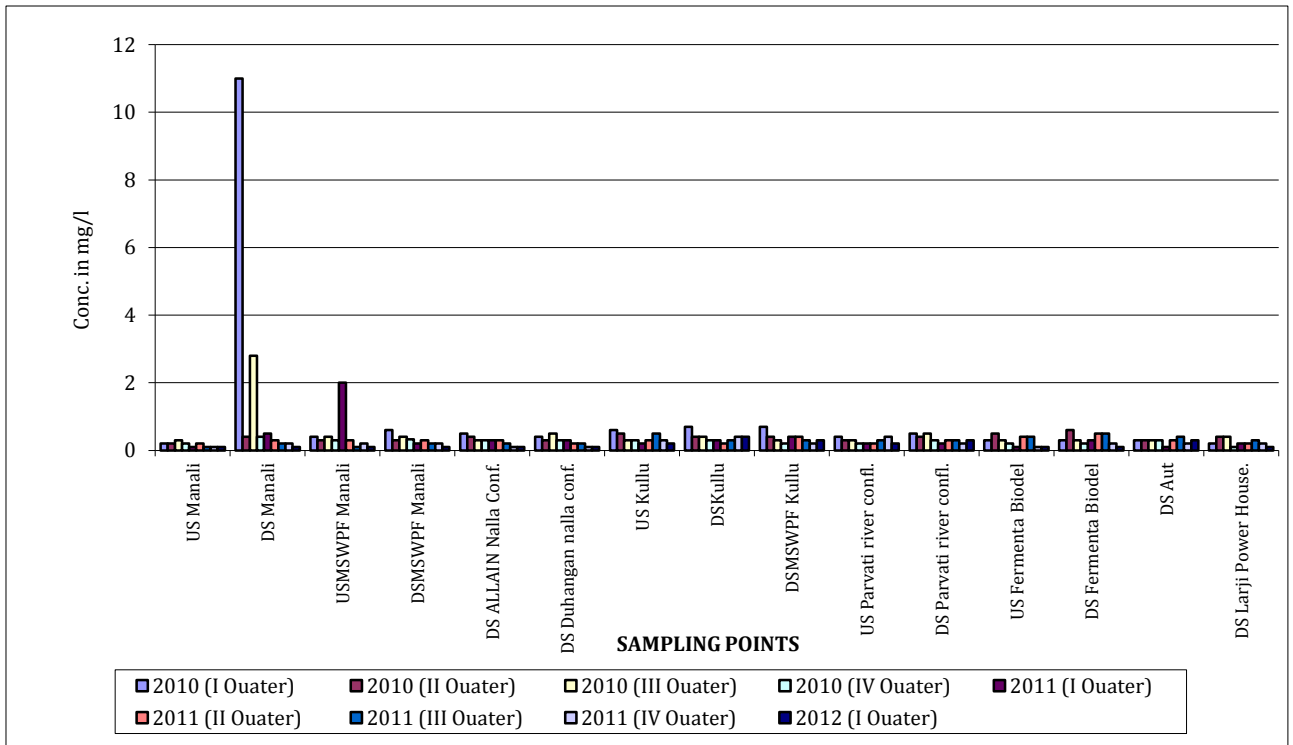
Figure 5 BOD Variation during study period

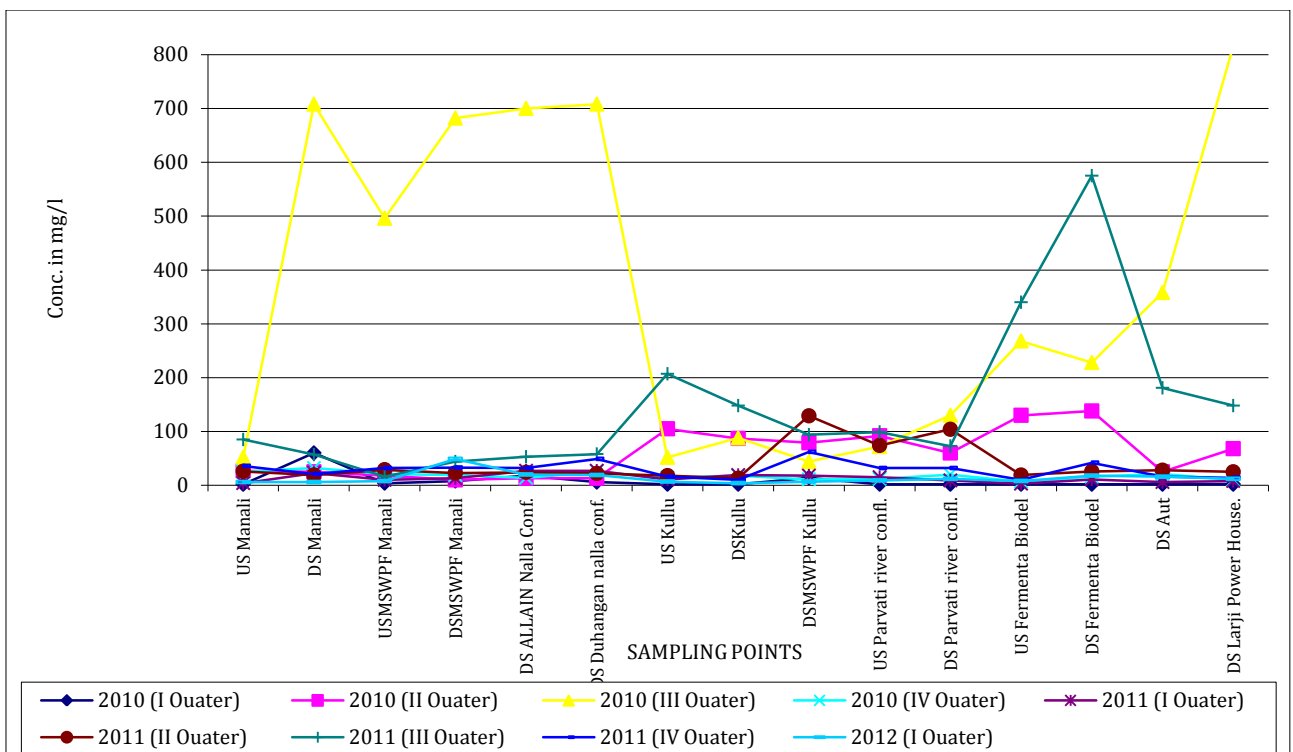
Figure 7 TSS Variation during study period
